THE RECOVERY, RECONSTRUCTION, AND ANALYSIS OF YENİKAPI 14 (YK
14), A MIDDLE BYZANTINE MERCHANT SHIP FROM THE THEODOSIAN
HARBOR EXCAVATIONS AT YENİKAPI, ISTANBUL

A Dissertation

MICHAEL RICE JONES

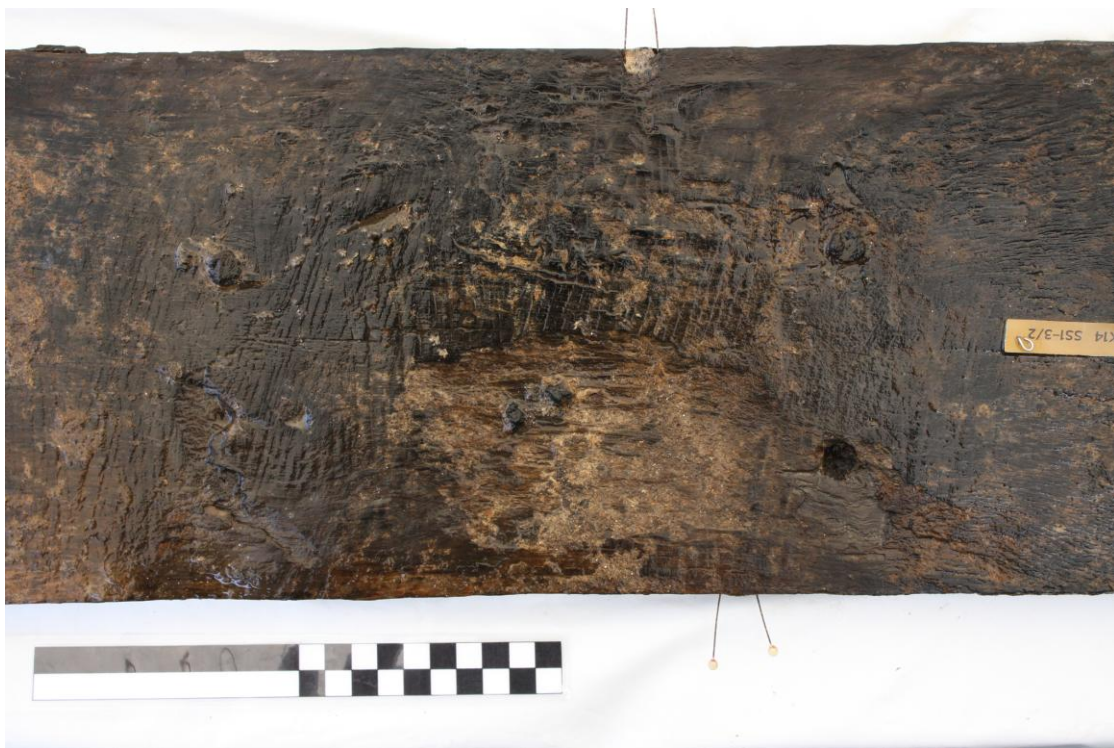
Figure 3.77: Plank SS 1-3 showing charring with saw marks and a depression most likely cut with an adze removed the charred surface.

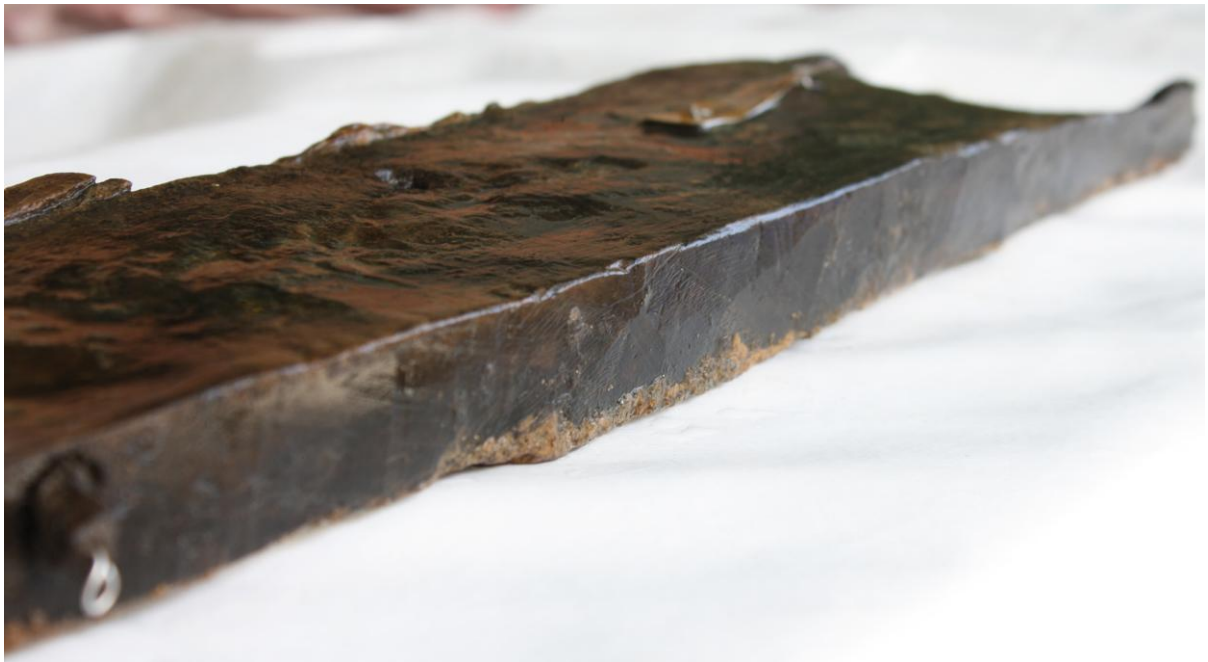
Figure 3.78: Well-preserved adze marks visible on the inboard surface of hull plank PS 8-3.

The inboard and outboard edges of the hull planks in most areas were clearly shaped with adzes. Adze marks were visible on many of the edges that were freshly exposed during the dismantling of the hull (**Figure 3.78**). In a few instances, a saw appears to have been used to shape straight diagonal scarf edges, such as the on the forward scarf of PS 2-2. The shaping of the edges frequently resulted in edge beveling, usually 0.1-0.5 cm in most areas, and often with the bevel reversing orientation on the same edge in different areas. Some of this beveling is probably accidental, a result of small variations in the angle of the adze used to shape the plank's edge, but in other areas the plank

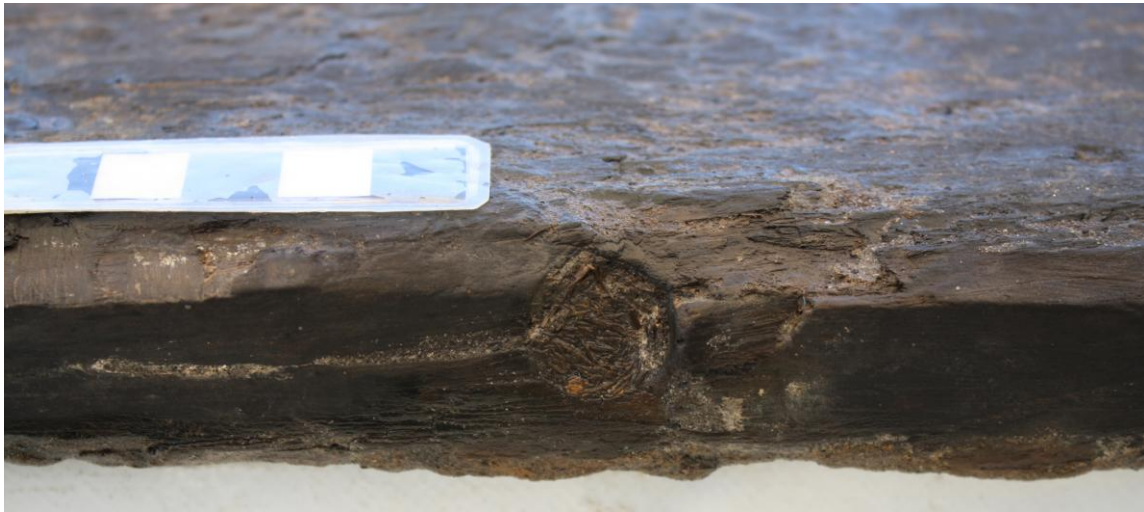
Figure 3.80: An angled, caulked hole in the keel edge of garboard plank SS 1-2. This hole was likely intended for a coak or garboard nail but was not used.

Other fastener holes appear to be intended for coaks or as pilot holes for nails, a common feature at the hood ends of planks and the inboard edges of the garboards (**Figure 3.80**). Still others may have been from the fastening of temporary cleats or props to the hull during construction. One set of caulked drilled holes runs from planks SS 6-3, SS 2-2, SS 1-3, PS 1-2, PS 2-2, and PS 7-2 at FL 45. These fastener holes, occurring near the forward end of the hull, are in a suitable location for securing temporary frames or cleats. Other fasteners such as the nail hole under FL 44 and a caulked hole in PS 10B, could have had similar functions. Some fastener holes could also simply be accidental or evidence of a change of plans during the construction of the hull.

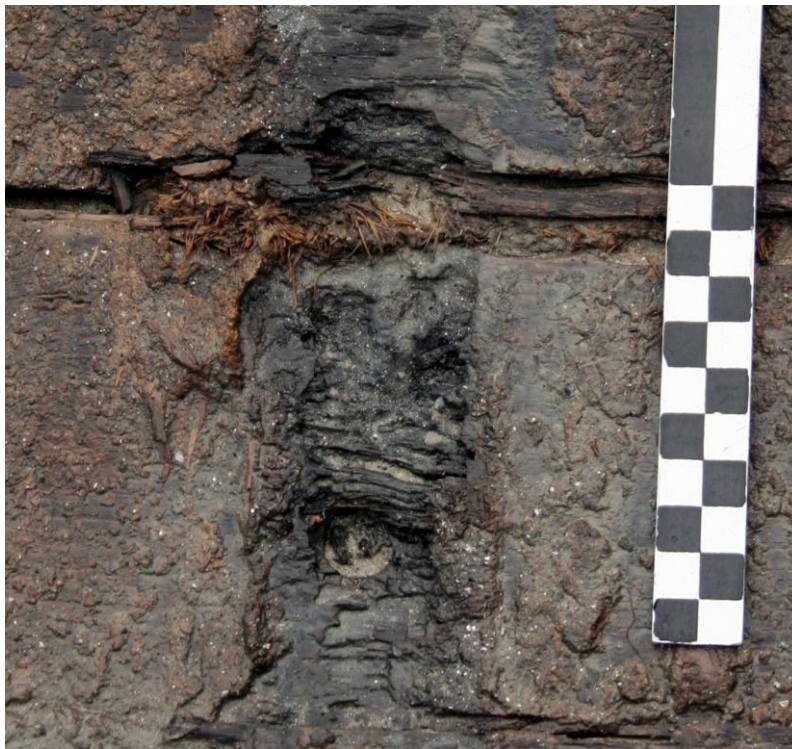
Figure 3.81: An example of repaired dry rot damage on the PS 3/PS 4 plank seam under FL 10.

Certain areas of the hull were damaged from wood rot. This damage most frequently occurred under frame locations, particularly in the space between drilled treenail holes in the planking and the treenails themselves (**Figures 3.81-3**). Both the frames and the planking were affected in many areas, often severely; in some areas, the treenail or coak had been destroyed and was no longer functioned as an effective fastener. Damage was particularly severe towards the ends of the ship, especially in the bow on strakes PS 6-10. The lack of pitch under most of the frame locations indicates that the hull planking was probably not pitched before the insertion of the frames.

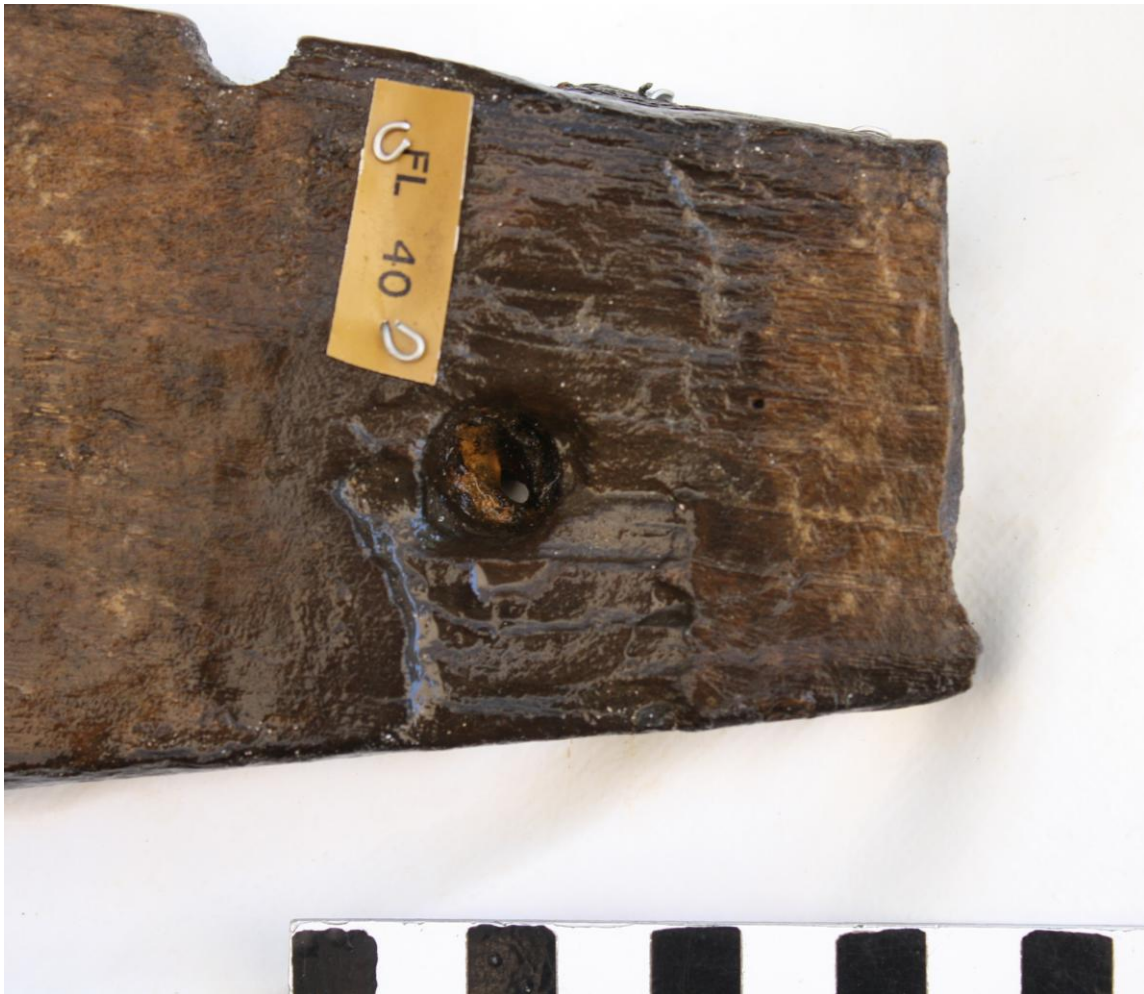
Figure 3.82: A rotted-out treenail under FL 40 on PS 10B seems to have been covered over with pitch.

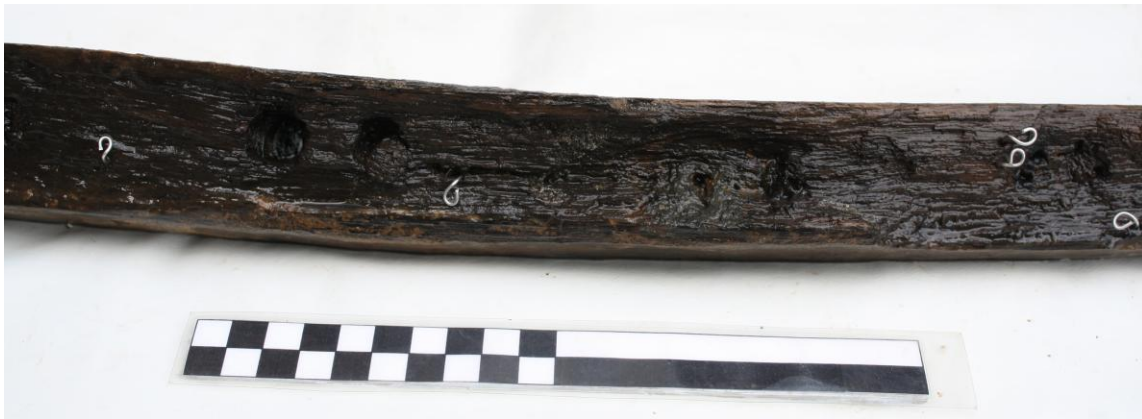
Figure 3.83: An example of severe dry rot to the outer face of a frame timber (FL 38).

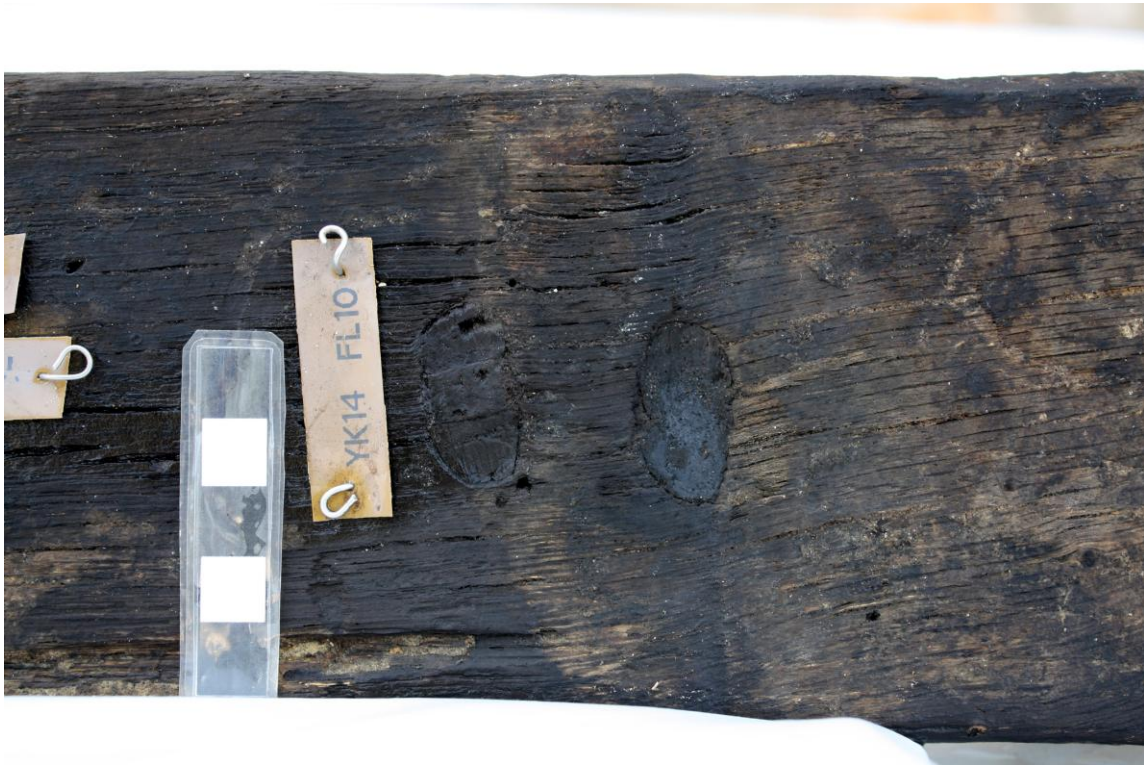
Figure 3.85: Inboard ends of coaks in the keel/garboard seams .Note the cut marks on the surfaces of the fasteners.

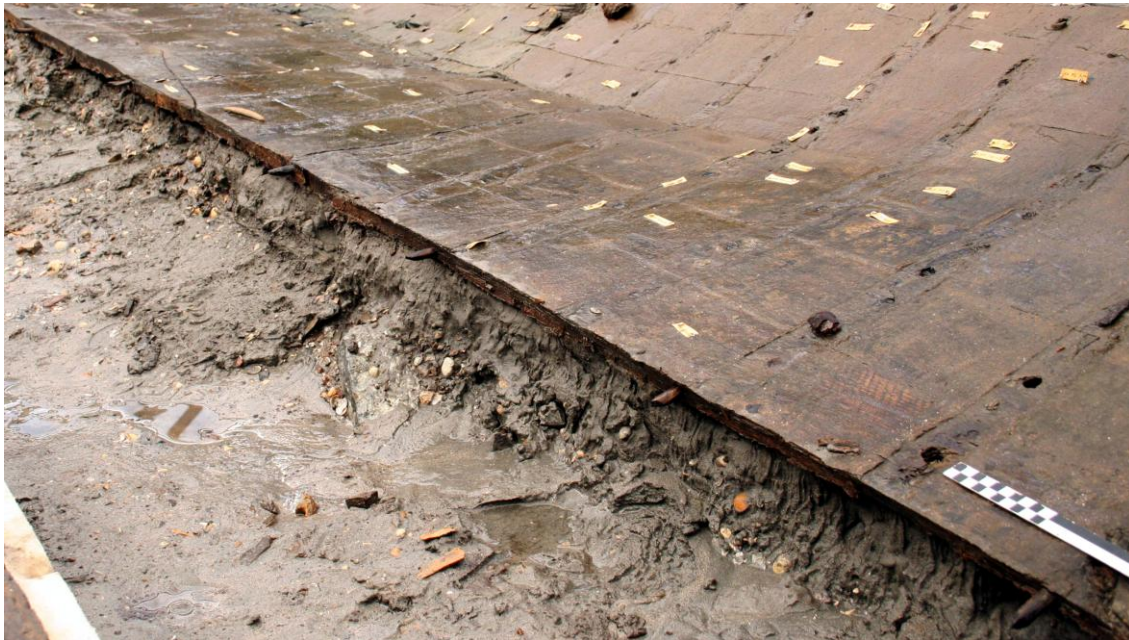
Figure 3.86: Overview of intact coaks protruding from the inboard edge of strake PS 2 during dismantling of the ship in 2007.

All of the hull planks up to, but not including, the first wale were edge-fastened to each other using coaks driven into the plank edges (**Figures 3.86-8**).³³⁷ Many coaks were carefully examined during cataloging; 33 intact examples were recovered, and others were fully exposed on the inner faces of hull planks so that their complete lengths could be measured. Hundreds of broken coaks and holes drilled for coaks in the edges of the hull planks were measured and examined during the cataloging of the timbers. Coaks show more variation in shape than trenails; they are usually round or polygonal in section, although a few with rectangular or square cross sections were also used. Some coaks have a relatively uniform diameter across the fastener, while others are thickest in the area of the plank seam or taper slightly so that the largest diameter is near the

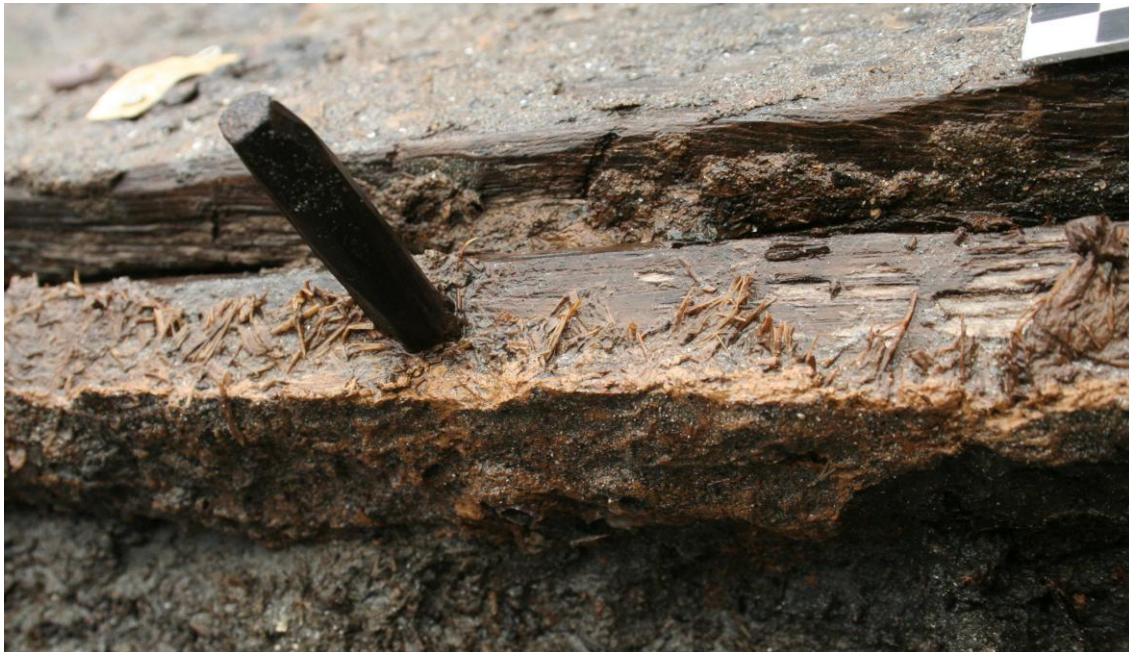
Figure 3.87: An intact coak protruding from the outboard edge of SS 1-1/1.

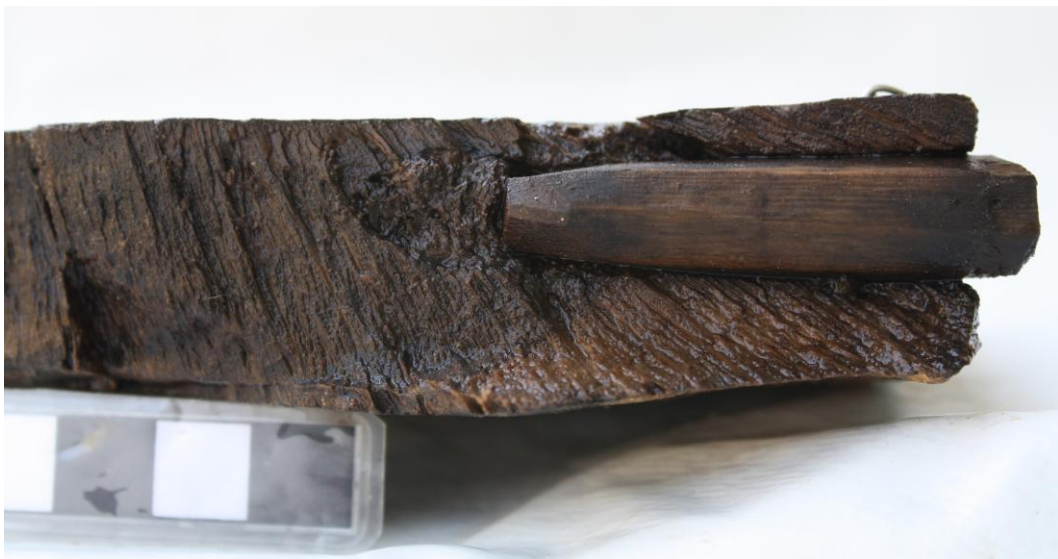
Figure 3.88: A coak exposed at a break in plank PS 2-2. Note the sawdust at the bottom of the drilled hole.

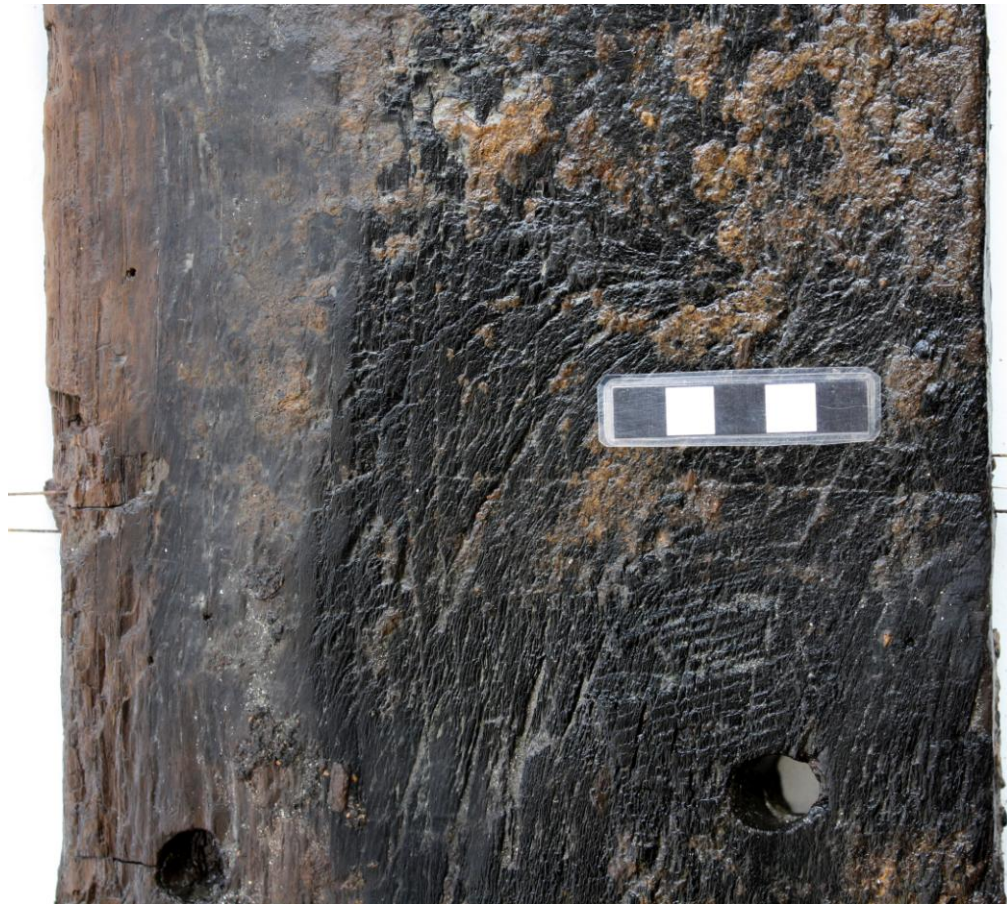
Figure 3.89: Score marks indicating a coak location (the coak is marked by the three pins in plank edge at right) in a charred area of the aft end of PS 3-1. Score marks and other tool marks were often particularly well preserved in charred areas.

The locations of many coaks were marked by scoring during the construction of the ship (**Figures 3.89-91**). The score marks were made with a knife or a similar sharp tool, and seem to have been intended to mark coak locations on adjacent planks so that holes drilled for the coaks could be aligned properly. The planks must have been cut to shape first, then bent and perhaps clamped into the correct position in the hull or held with temporary cleats or props. The score marks were made at fairly regular intervals when the pieces were positioned in this way, and were later separated to drill the coak holes. Approximately 177 fully or partially preserved score marks were found, often under a

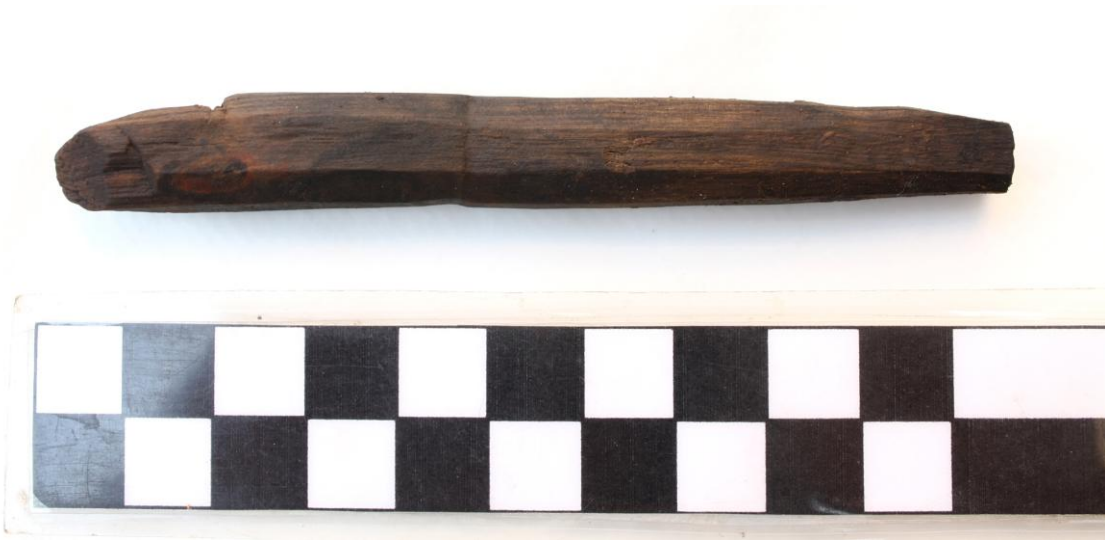
Figure 3.92: Pressure mark from plank seam on an intact coak.

The depth to which a coak was driven can often be discerned by the presence of a pressure mark on the fastener (**Figure 3.92**). In many cases, there is also a cut from a knife or a similar sharp tool at the seam location, usually corresponding to the outboard side of the seam location (**Figure 3.93**).

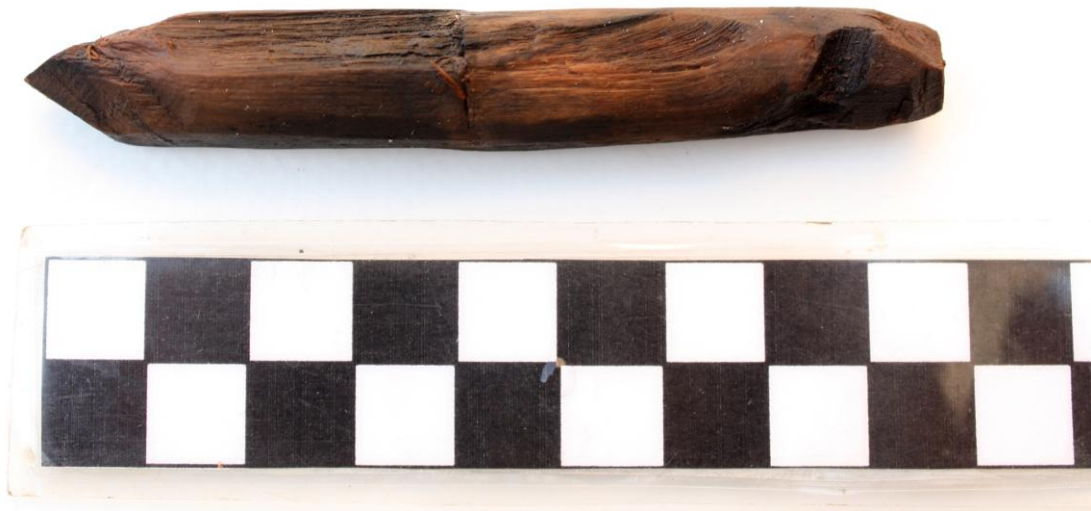
Figure 3.93: Knife (?) cut at the location of a plank seam on an intact coak.

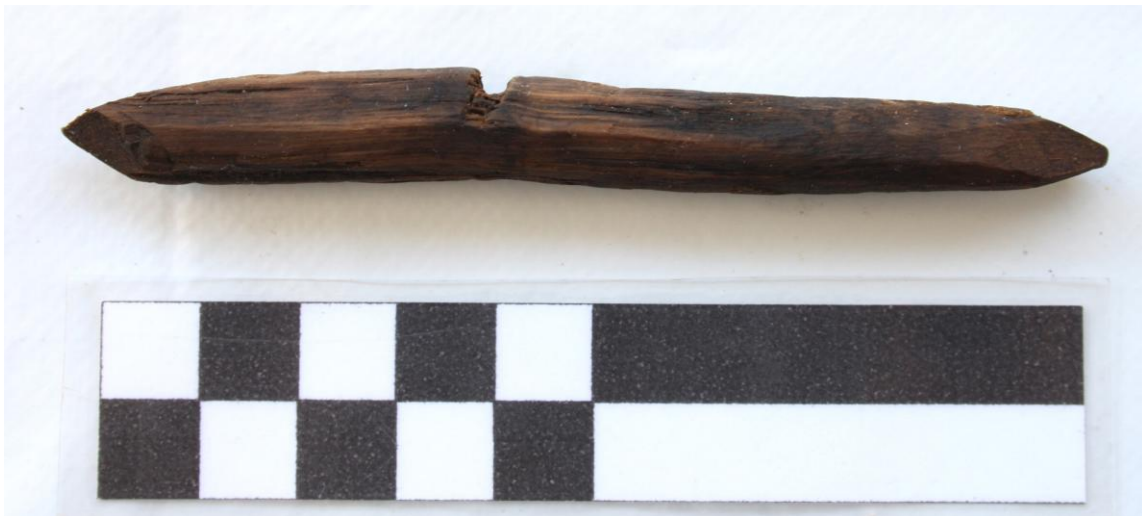
Figure 3.94: An intact coak removed from the PS 2/3-plank seam from between FL 37-38. The notch in the coak's surface occurs at the location of the plank seam and was probably caused by a caulking iron. The notches faced the outboard side of the plank and retained pitch and caulking deposits in them.

In some cases, these are shallow incisions, while in others they are wide gouges, often filled with pitch or with caulking fibers forced into them. The latter coaks appear to have been heavily damaged by caulking irons, possibly from multiple caulking episodes (**Figures 3.94-8**). In all, eleven intact coaks with wide gouges on the outer-face half of the coak at the plank seam were recovered: nine were found on PS 2-PS 3-plank seam between FL 19 and FL 39, with an additional two on the PS 3-PS 4-plank seam between FL 22-24.³⁴⁰ On five other coaks, cut marks or possible cut marks were observed on the outer face: two on the PS 2-PS 3-plank seam and two on the PS 3-PS 4 plank seam.³⁴¹ Similar cuts were observed on intact coaks from the tenth-century wreck YK 5, but not

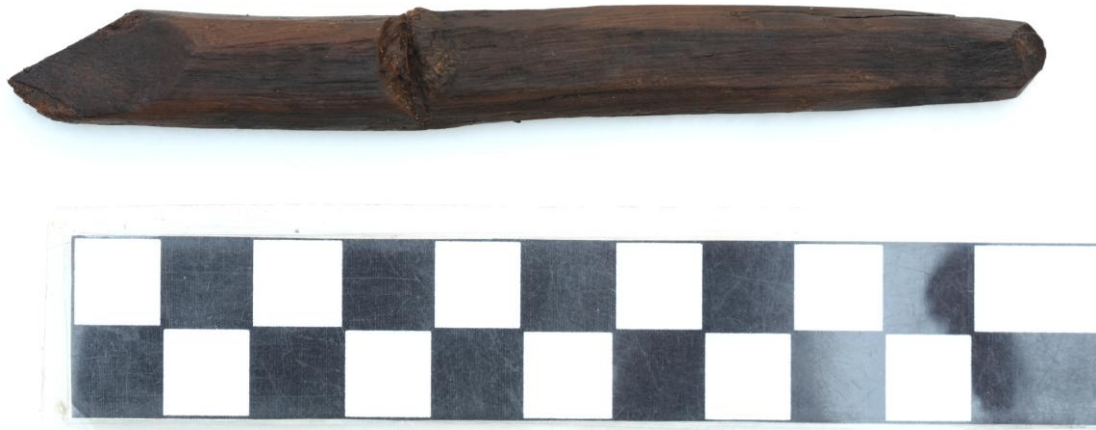
Fig. 3.95: Caulking iron damage on an intact coak from the PS 2/3 plank seam under frame FL 34.

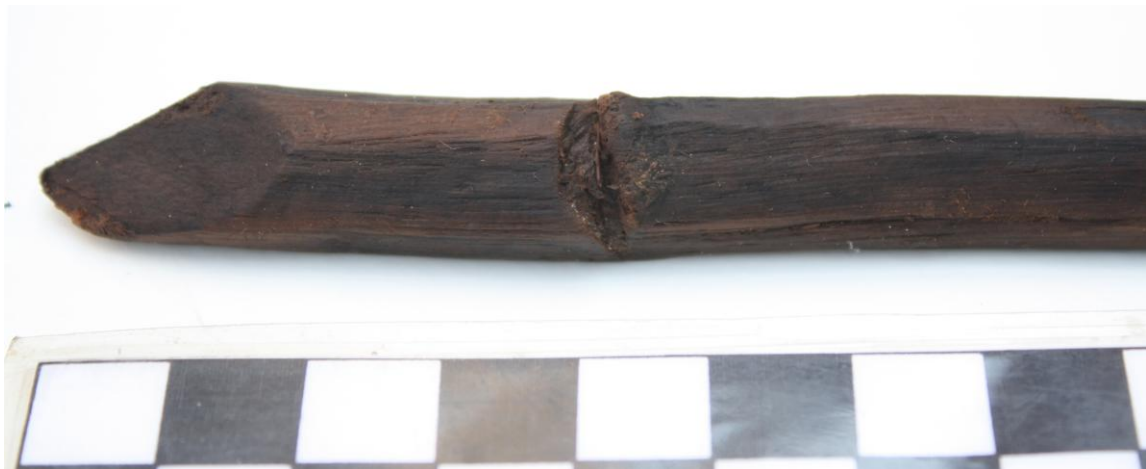
Figure 3.96: Detail of caulking iron damage on an intact coak from the PS 2/3 plank seam under frame FL 34. Note the caulking deposit in the cut from a caulking iron.

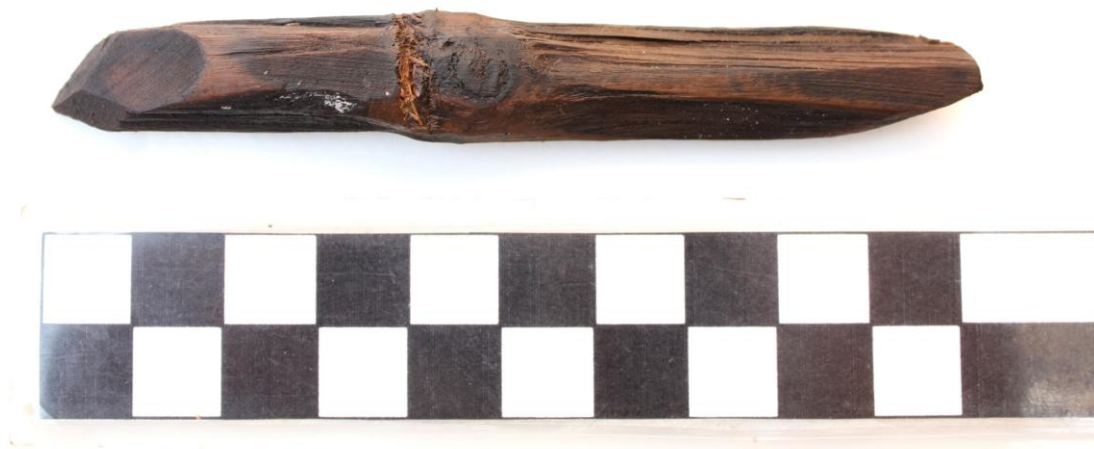
Figure 3.97: Coak from the PS 2-PS3 plank seam between FL 23-24, with caulking iron damage.

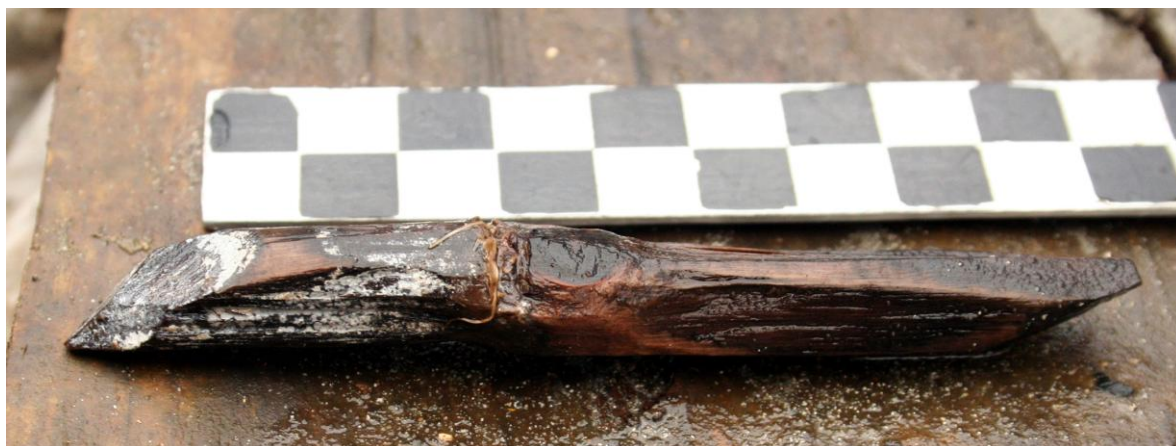
Figure 3.98: Coak from the PS 2-PS 3-plank seam between FL 23-24, after its discovery during the excavation in 2007. Note the white deposits on the inboard end of the coak at left in the photograph.

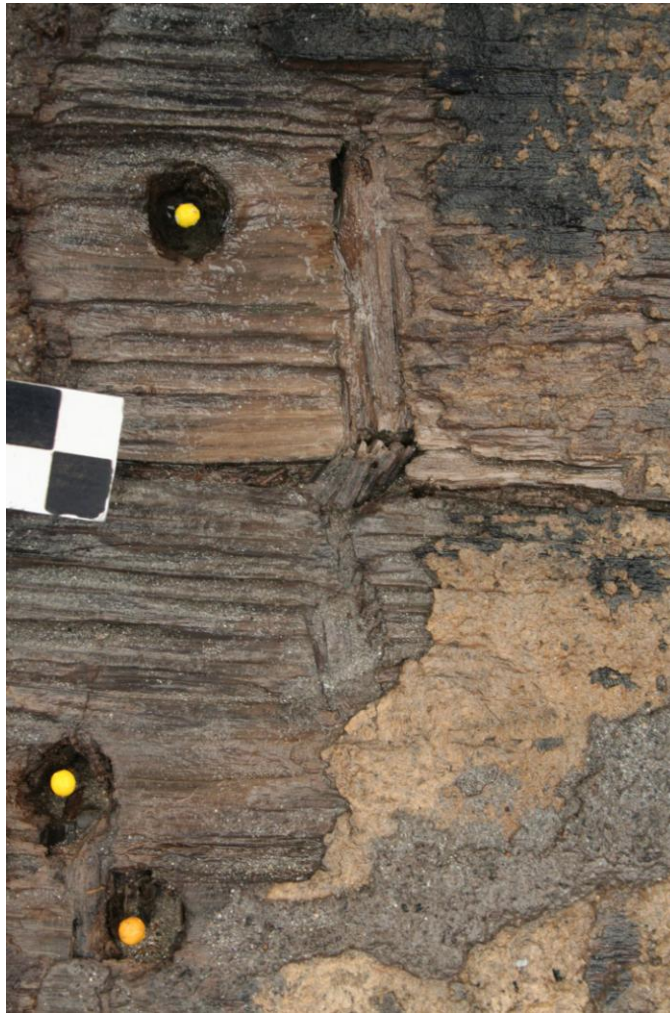
Figure 3.99: A coak distorted from shear stress and damaged by wood rot, in PS 9 and 10B, under the location of FL 47.

Some coaks show evidence of severe distortion along the plank seams; in some parts of the hull, the positions of the strakes must have shifted up to 0.5 to 1.0 cm (**Figure 3.99**). This is most dramatically shown by a distorted but complete coak from the turn of the bilge in the PS 6-PS 7 area between FL 41 and 42 (**Figure 3.100**). This type of distortion was concentrated on coaks towards the ship's extremities. Depressed areas around the edges of some coak holes in the edges of hull planks were caused by the distortion of the coaks. This feature was particularly common around the seams of strakes PS 6 through PS 12 at either end of the hull (**Figure 3.101**). That coak deformation is most pronounced towards the ends of the ship above the turn of the bilge suggests that it is due to hogging of the hull. This type of stress is inevitable in a wooden ship over time, as the ends of a hull are subject to less support from buoyancy than its central section. These features may be further evidence of the age of the vessel.³⁴³ However, the settling of the hull planking on the seabed after the sinking of the ship could also be a contributing factor to this distortion as well.³⁴⁴

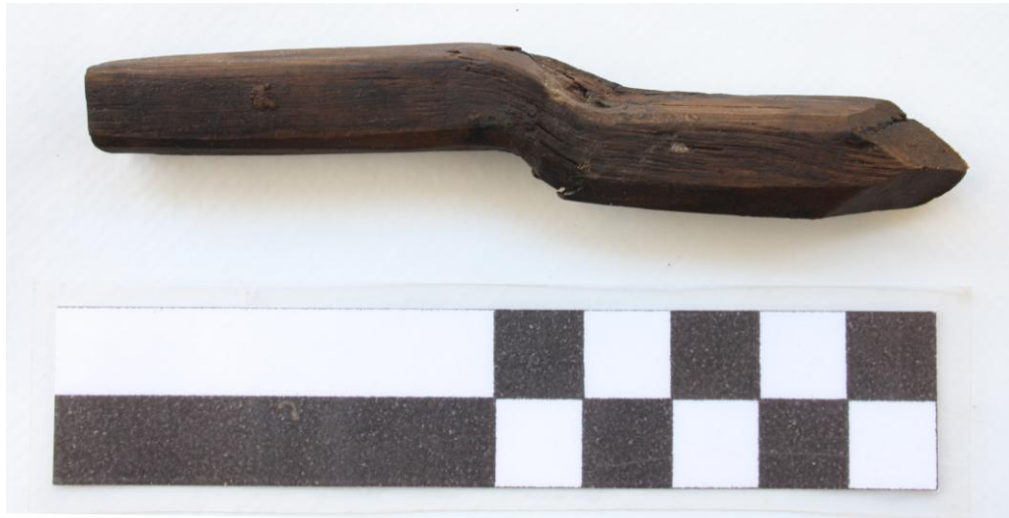
Figure 3.100: Intact coak from PS 6-PS 7 seam, between FL 41-42. Note the distortion of the coak at the plank seam due to hogging.

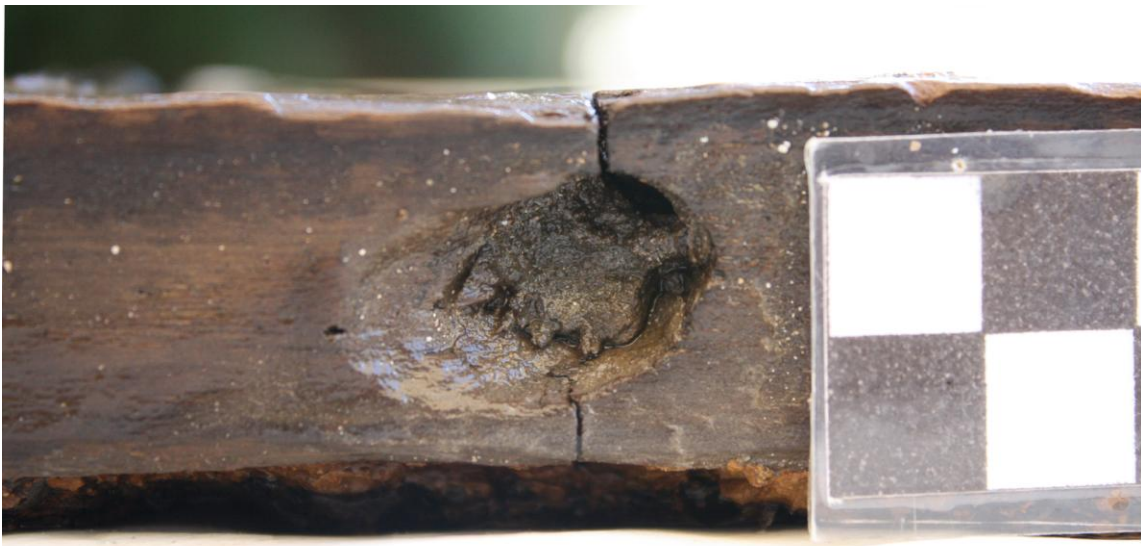
Figure 3.101: The depression around the left side of the coak hole is from shear stress distorting the coak on the PS 10/11 plank seam.

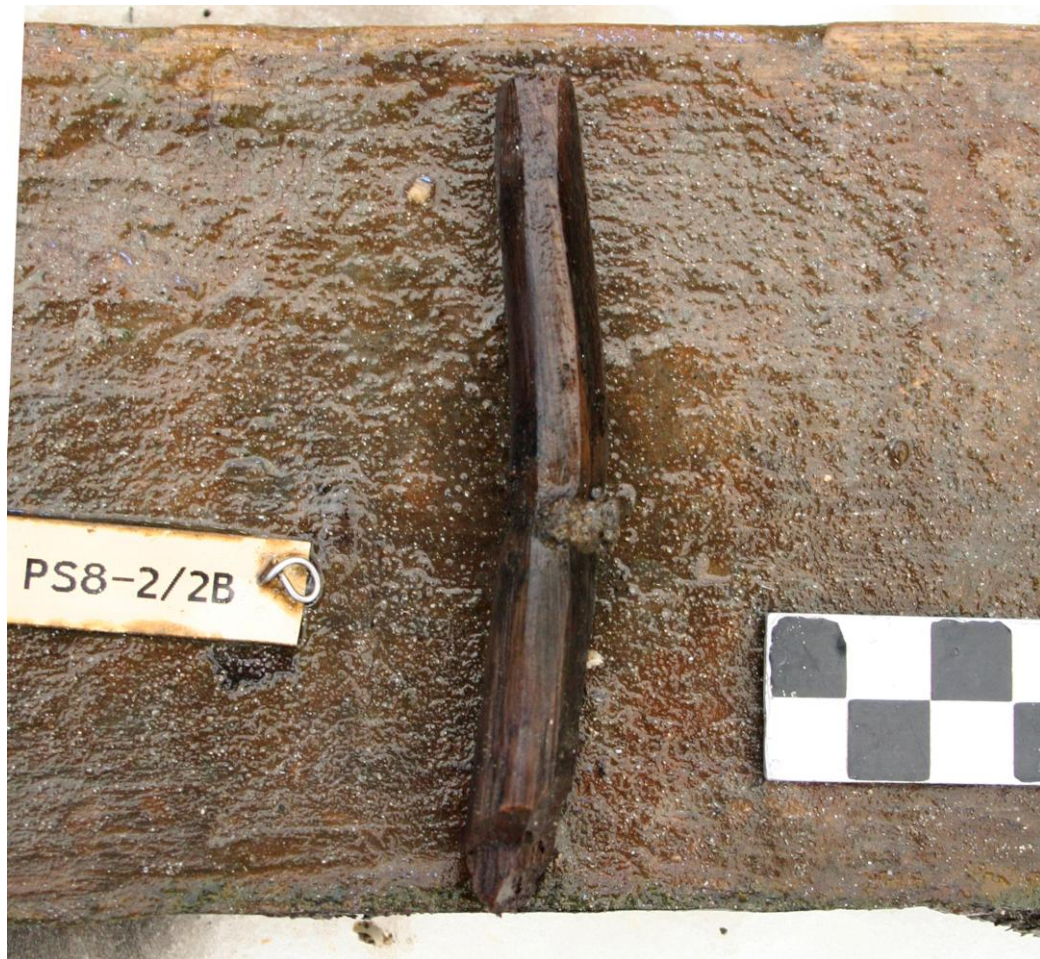
Figure 3.102: Coak bent at the turn of the bilge on the PS 7-PS8 plank seam.

The turn of the bilge was one of the most difficult areas of the hull to assemble with edge-fastened planking. In this area, broken coaks were found along the plank seams appear to have been broken in antiquity, either before or during the sinking of the ship. Other complete coaks appear to have been bent during construction in areas where the turn of the bilge was particularly sharp, particularly in the forward and amidships section of the hull along the PS 6, 7, and 8 seams (**Figure 3.102**).³⁴⁶ Much of the plank PS 7-2 was bent into a concave shape, another apparent sign of the mechanical stress on this area to the hull planking. Some drilled holes on the inboard sides of coak joints were angled, with the inboard ends of the coak holes emerging on the planks' outer faces; this feature was not observed in other areas of the hull planking (**Figure 3.103**).³⁴⁷

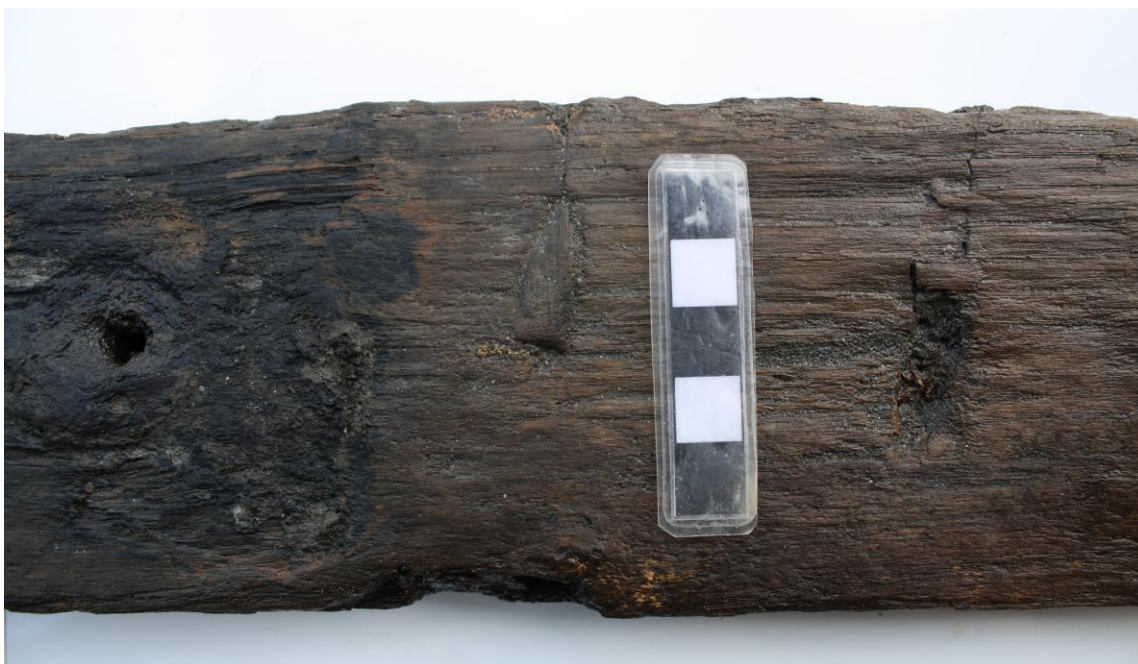
Figure 3.103: Ends of two coaks emerging from the outer face of plank PS 5A/2-4. These coak may have been deliberately angled to compensate for the sharp turn of the bilge in this area of the hull.

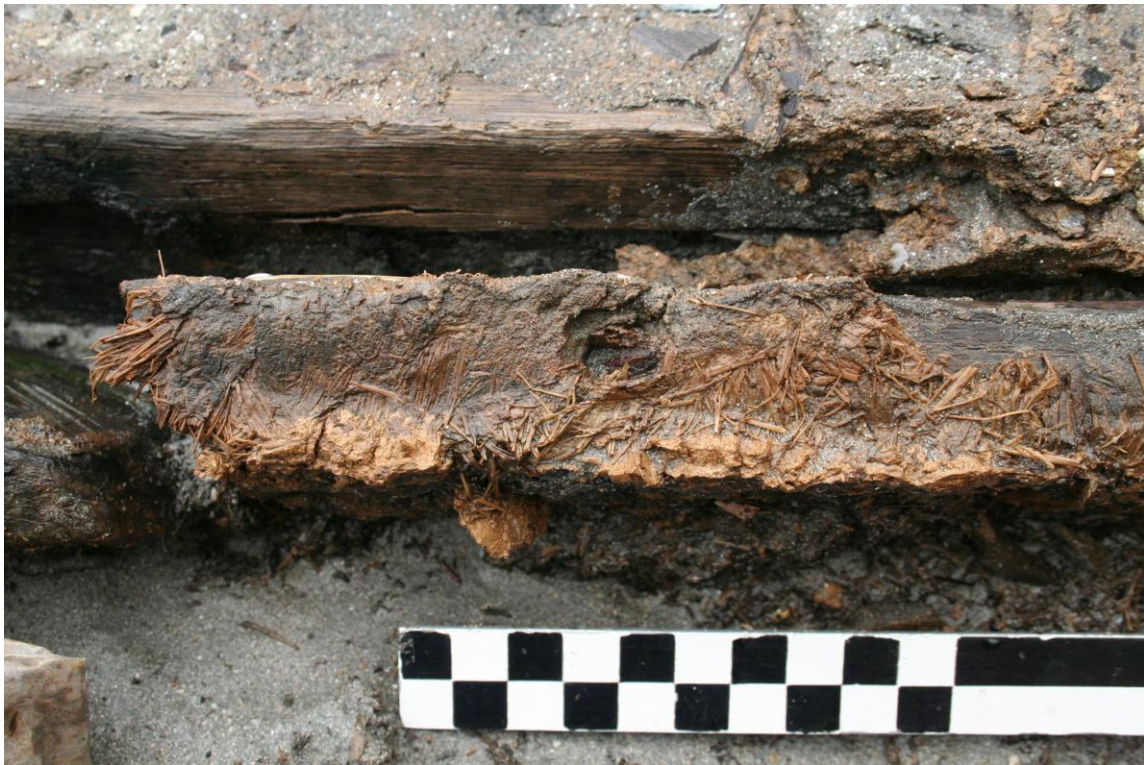
Figure 3.104: Caulking around a coak in SS 1-SS2 plank seam. The caulking deposit shown is fairly thick but typical of those in YK 14's plank seams.

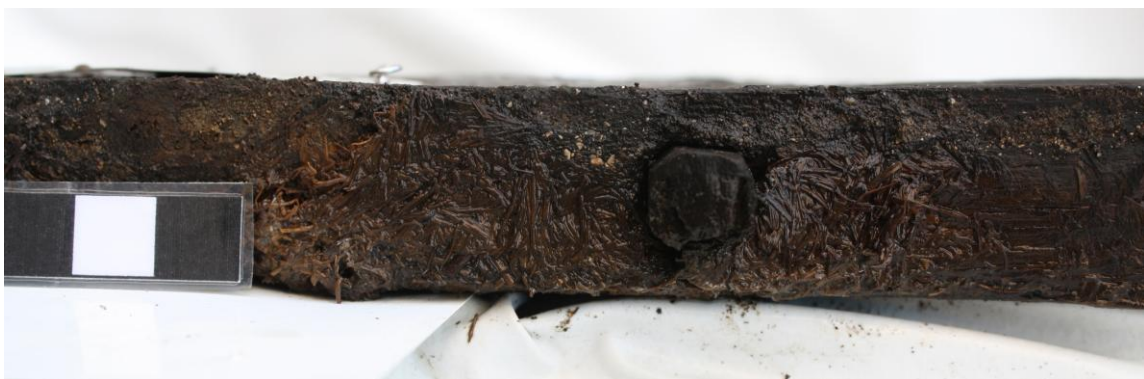
Figure 3.105: Caulking around a coak in the upper edge of plank PS 4-2. Note that the caulking fibers surround the coak everywhere except at the inboard side of the plank edge, which is instead covered with pitch that may have leaked into the seam from inside of the hull.

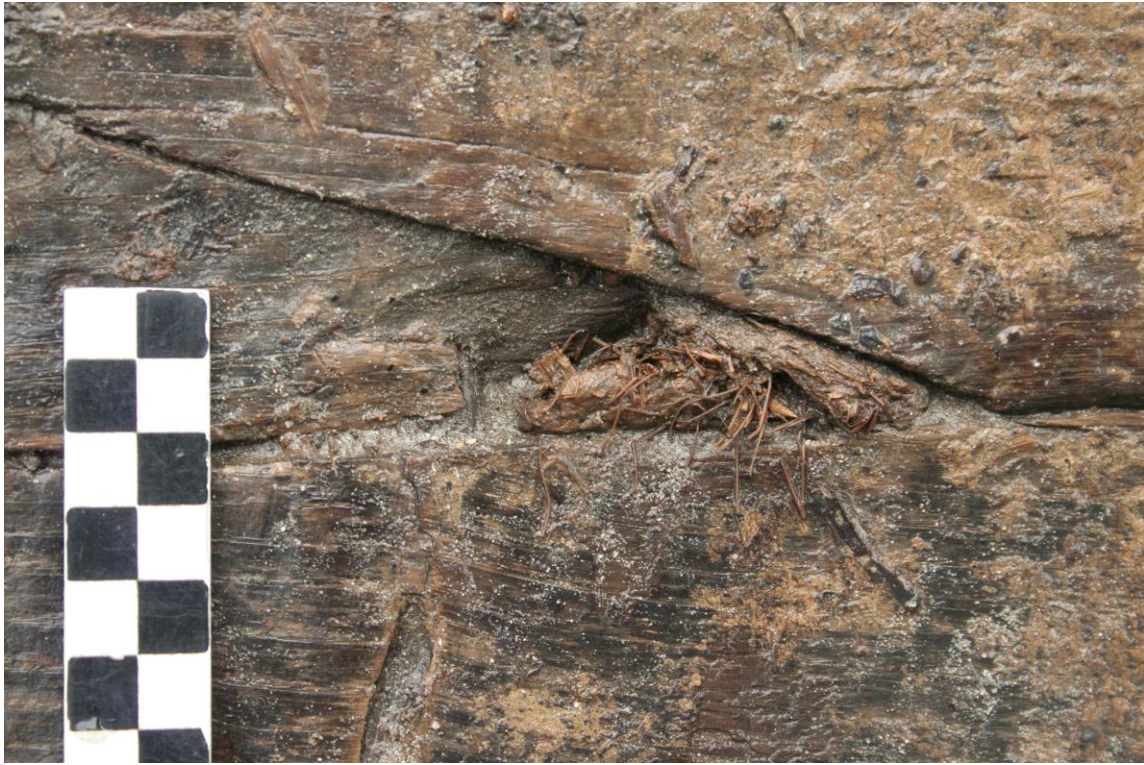
Figure 3.106: Caulking repair at the aft scarf tip of PS 9-3.

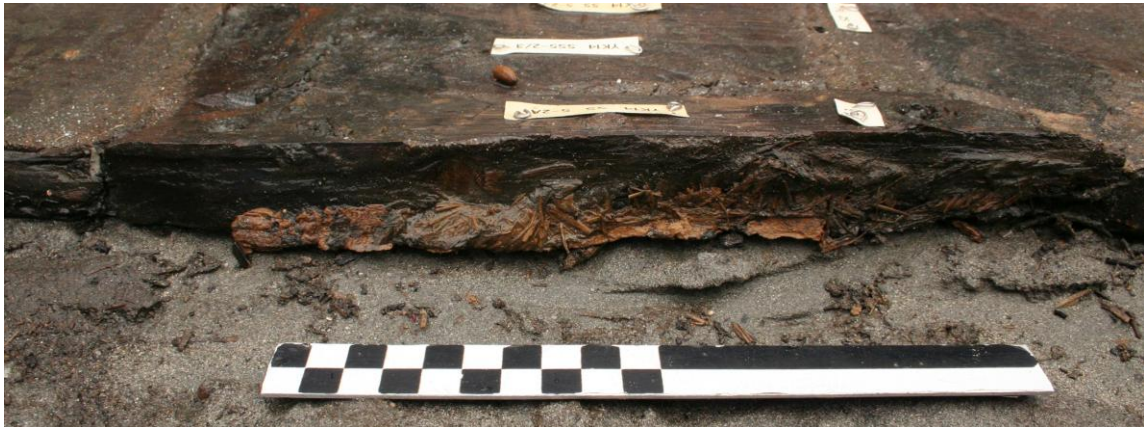
Figure 3.107: Caulking on the outboard edge of a repair piece, SS 5-2A. Note the cut coak on the seam from the plank's previous use, and the concentration of the caulking on the outboard half of the plank seam.

The orientation of the caulking fibers in the plank seams may offer some clues to the role of driven versus laid caulking, but this evidence is often ambiguous. In some areas, caulking fibers seem to be oriented perpendicular to the inboard and outboard edges of the planks. Caulking fibers driven into the grooves in the port and starboard faces of the keel timbers and in the thick caulking deposits around some of the repair planks were oriented in this way. In other areas, the fibers run more parallel to the plank edges. The seams at the wale and on some repair planks cover only the outboard half of the plank seam (**Figures 3.107-8**). It is likely that these upper seams were sealed with caulking driven from outside of the hull, since no edge fasteners were present.

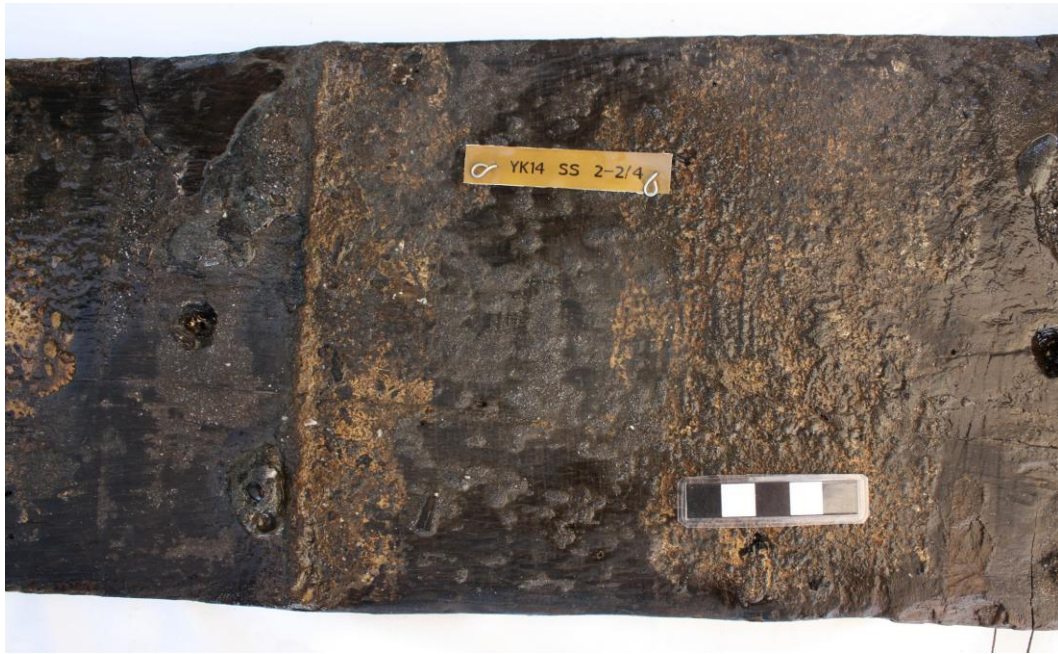
Figure 3.109: A worn area on plank SS 2-2, possibly used for bailing bilge water out of the hull. Striations across the width of the plank in an area without preserved pitch; the gray deposits on the plank's surface are concretion, which indicates that these striations are an old feature and were not made during the excavation.

Bilge water would have been removed from the ship using a bucket or scoop; the vessel is small enough not to have required a permanent bilge pump. Possible evidence for a bailing in some sections of the hull consists of an absence of pitch deposits combined with lateral wear marks on the inner faces of planks PS 2-2 between FL 35-37, and SS 2-2 between FL 33-35 (**Figure 3.109**). Since there appears to have been no clearly delineated sump area for bilge water in the ship, bailing may have occurred in other sections of the ship as well.
